The Causes of Condensation

Q: I have customers who complain about condensation forming on insulated windows and skylights. What should we look for in a window or skylight to prevent this problem?

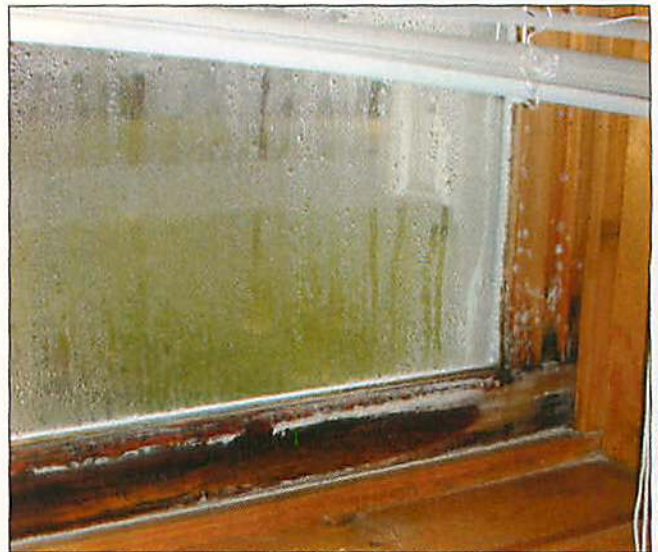
FIGURE 1. High indoor humidity levels, aggravated by a window blind that reduced the drying effect of air circulation, has created a condensation problem that has led to mold growth. In this case, the homeowner's lifestyle lies at the root of the problem, but it's not helped by an ordinary insulated window without warm-edge low-conductive glass.

problem that leads first to peeling paint, then to mildew and mold, and eventually to rot (**Figure 1**).

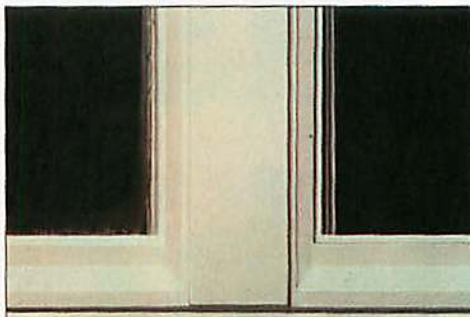
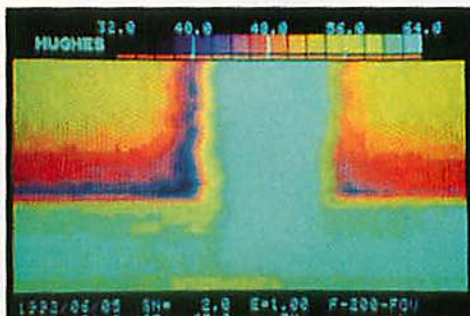
FIGURE 3. In the photos shown at left, the window on the far left (in both the photo and the thermograph) has a standard edge spacer — a highly conductive piece of extruded aluminum that quickly lowers the temperature at the edge of the glass and allows the indoor humidity to reach its dew point. The window on the right of each image has edge spacers often referred to as “warm-edge technology.” These spacers conduct less heat, lowering the window’s potential for edge condensation.

In new construction. Invest in a window that uses warm-edge technologies to reduce conduction at the edges of insulated glass units. This can keep the window edges warm and reduce the chances for condensation to form

(**Figure 3**). However, because condensation forming on the edges of an insulated glass unit indicates excessive moisture levels, it is usually better to solve the humidity problem before investing in window upgrades.

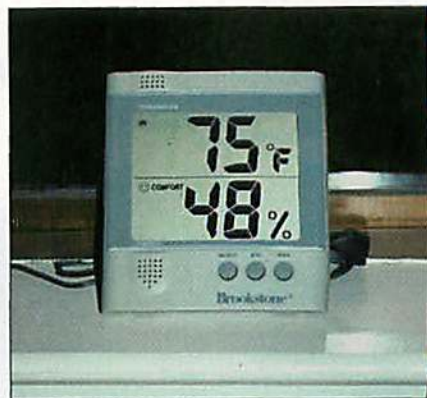
FIGURE 4. Prices for a digital hygrometer range from about \$30 to \$300, but a low-cost model such as this one is sufficient for most remodelers. This tool is primarily an aid for talking to clients about temperature and humidity and explaining the causes of condensation on glass even when it's not visible.

I recommend that contractors carry a digital hygrometer to measure and record indoor relative humidity while in customers’ homes (**Figure 4**, page 18). These relatively low-priced tools can go a long way to communicating clearly with clients about the indoor environment and what the options are for fixing a problem.
